# Manhole Inspection Summary

Manhole # S41G\_\_030MH

Insp Date: **11/6/08 2:03 PM**

**Location** Address: **1142 e pratt st**

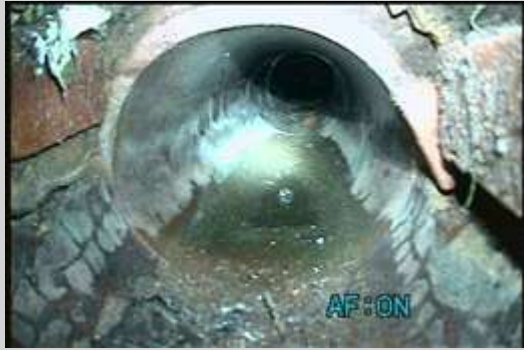
6 O'Clock Inflow

8 in. Circular Gravity Sewer  
Pipe In @ 6 O'Clock

Pipe Material: **Clay** ☐ Pipe Lined

Infiltration: **None** Pipe Seal Cond: **Unknown**
